WP3: Muon $g-2$ Calibration System Update

D. Cauz, C. Ferrari
MUSE Scientific Board Meeting
Sept 14th 2018

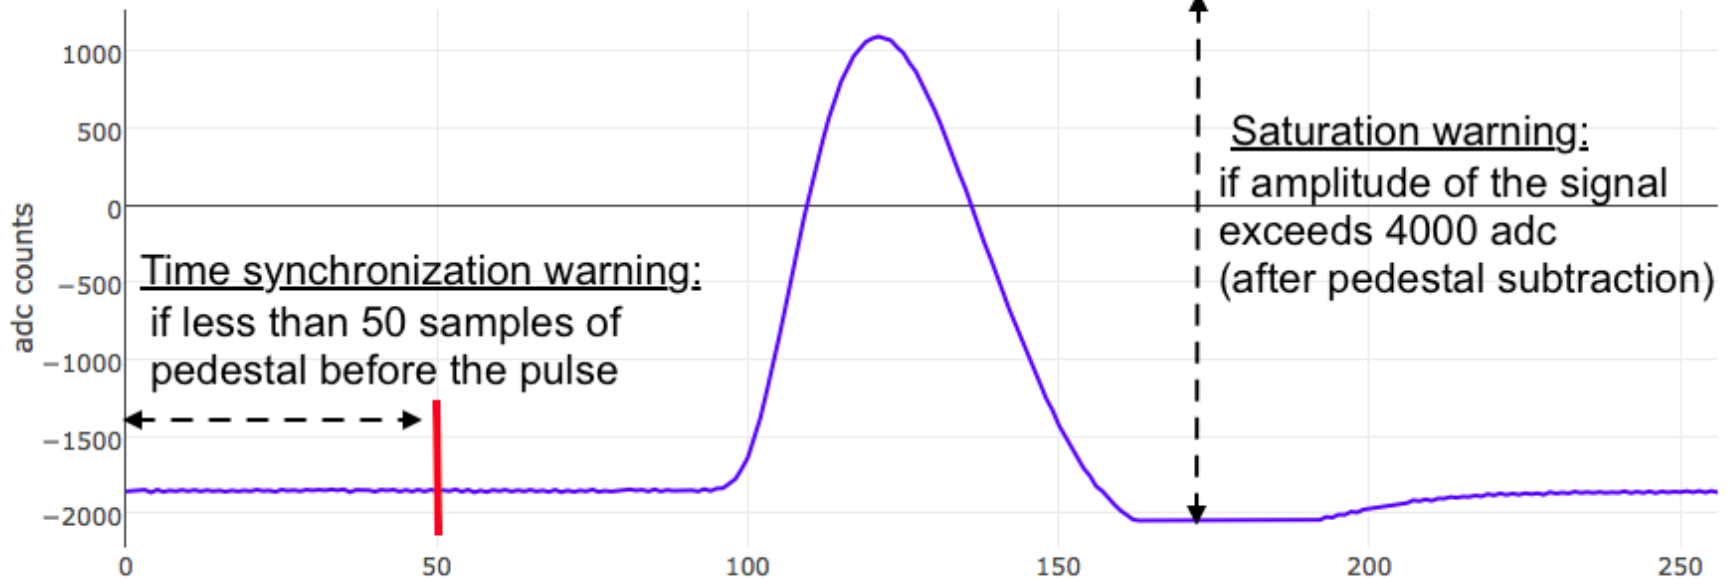
Now DQM Laser Monitors software (ART SIDE)
checks the quality of laser traces collected by DAQ

Example of warning conditions for pulses

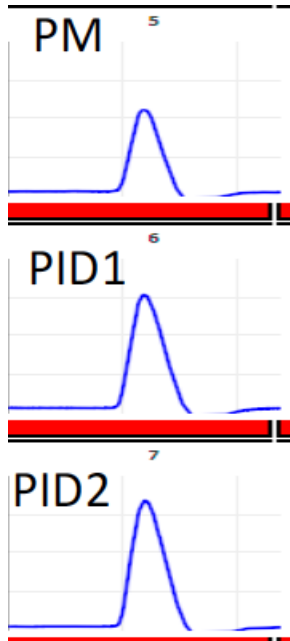
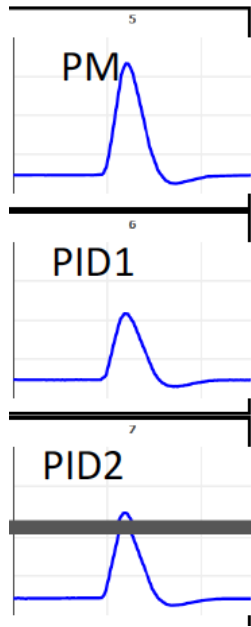
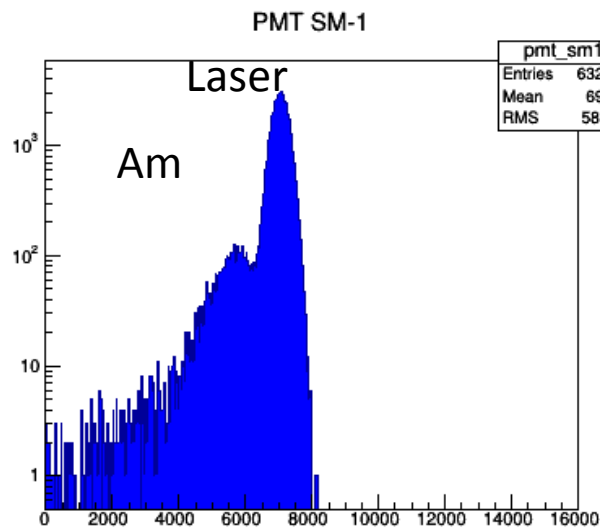
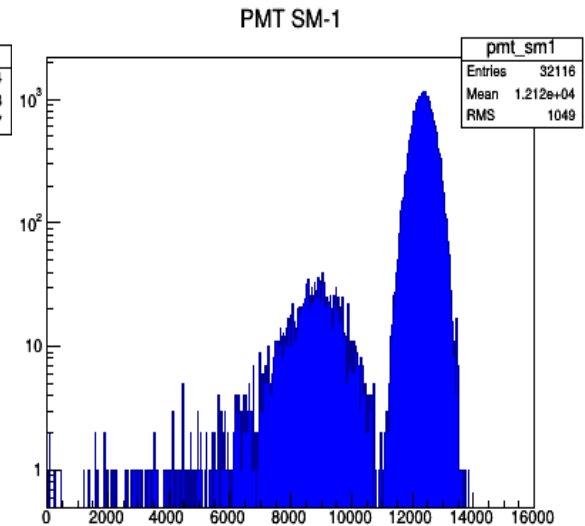
Update HW source monitor

- PID saturation fixed
- Overlapping of asynchronous (Am) and synchronous (laser) signals fixed
- Asynchronous acquisition mode now available

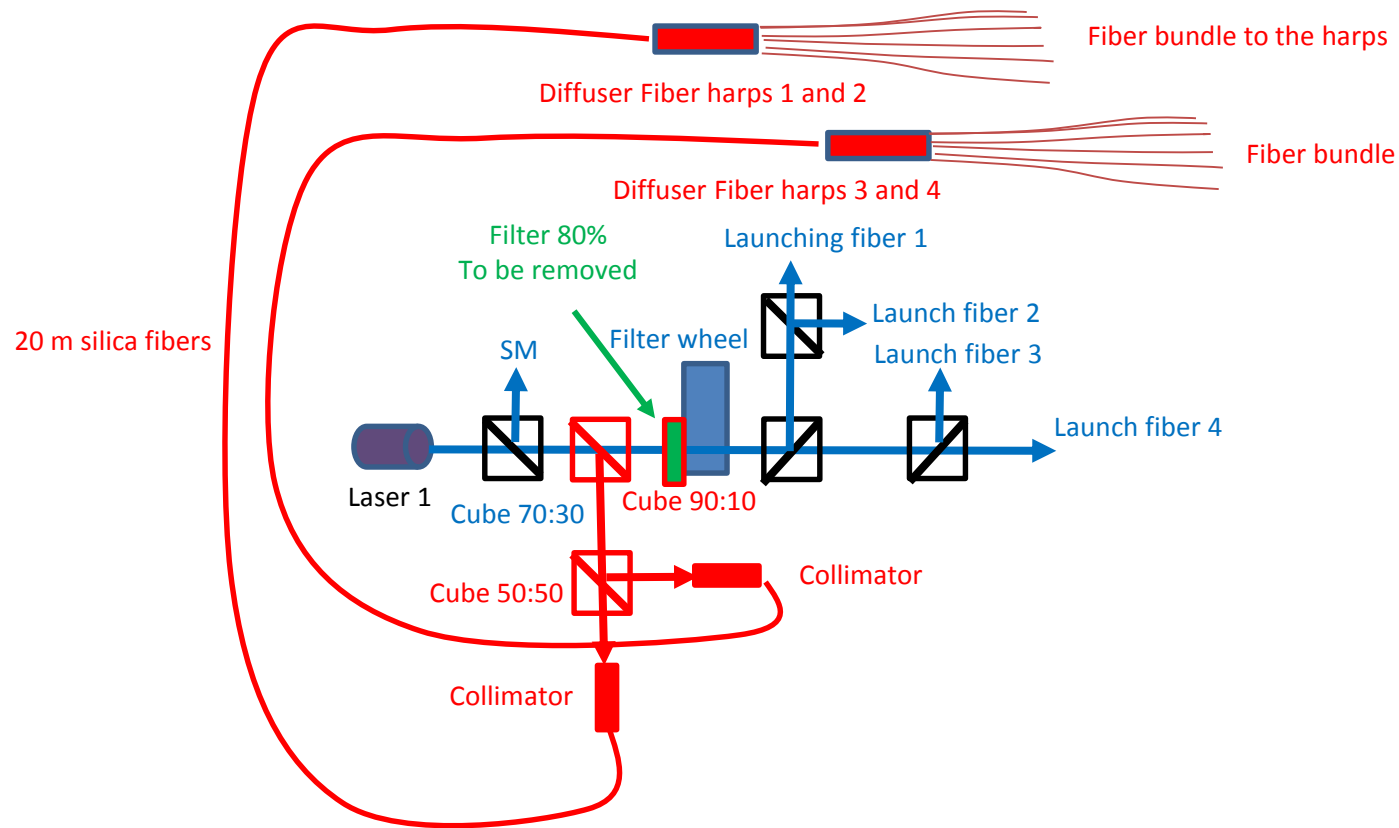
Laser pulses to the Fiber Harps

Red components are the new ones, green component is the old one to be removed

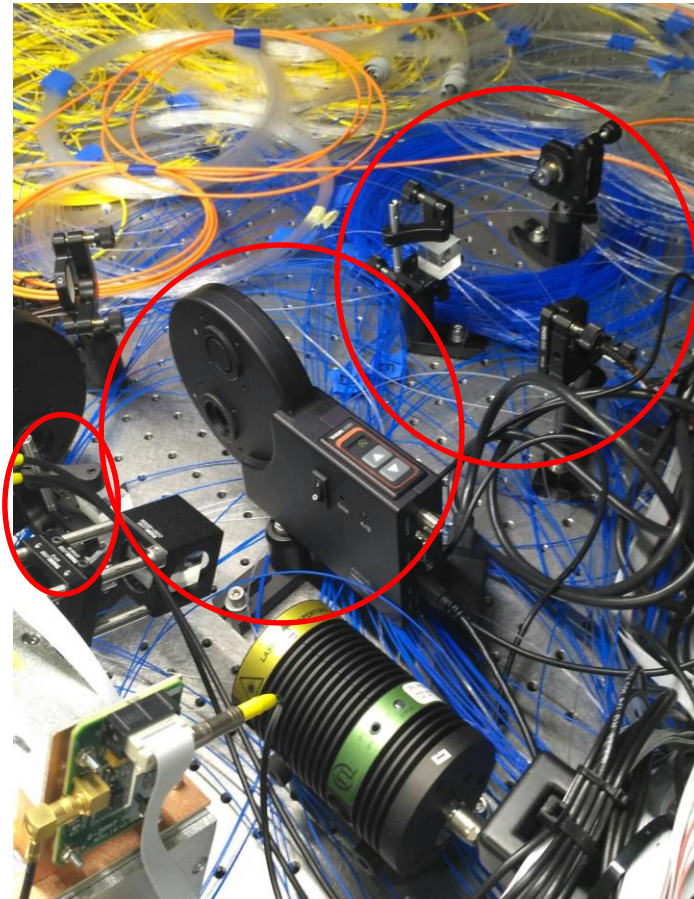
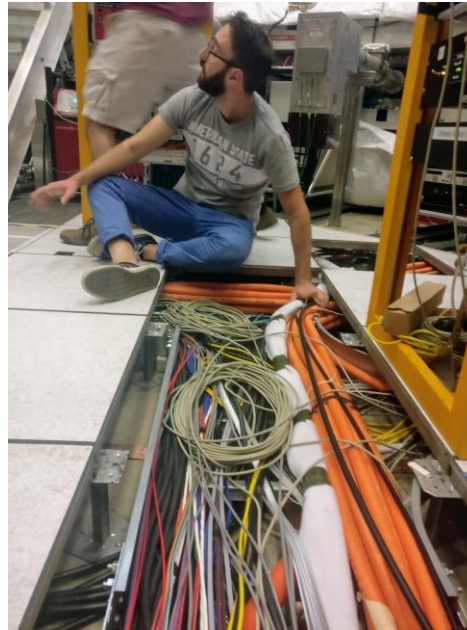
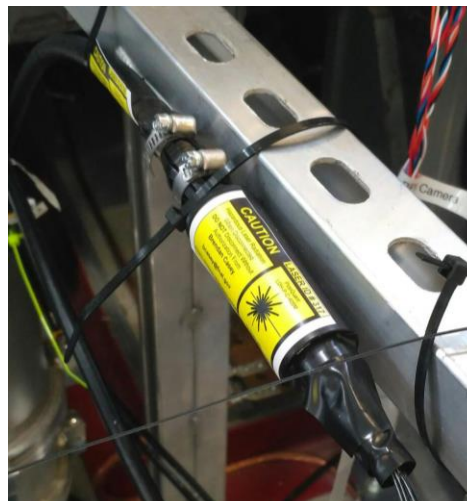
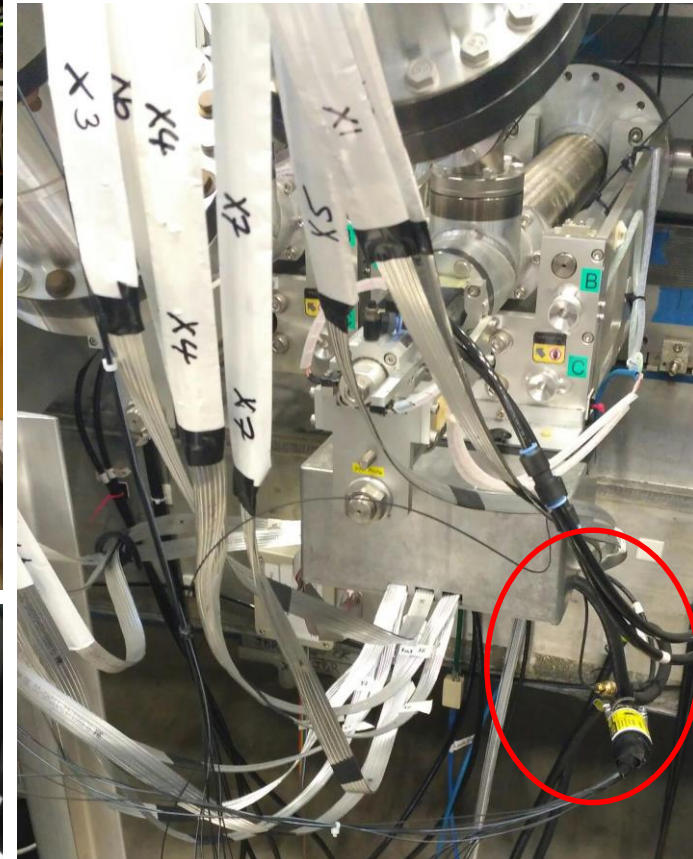
Laser pulses to the Fiber Harps

- Installation of the optics and the two new optical fibers

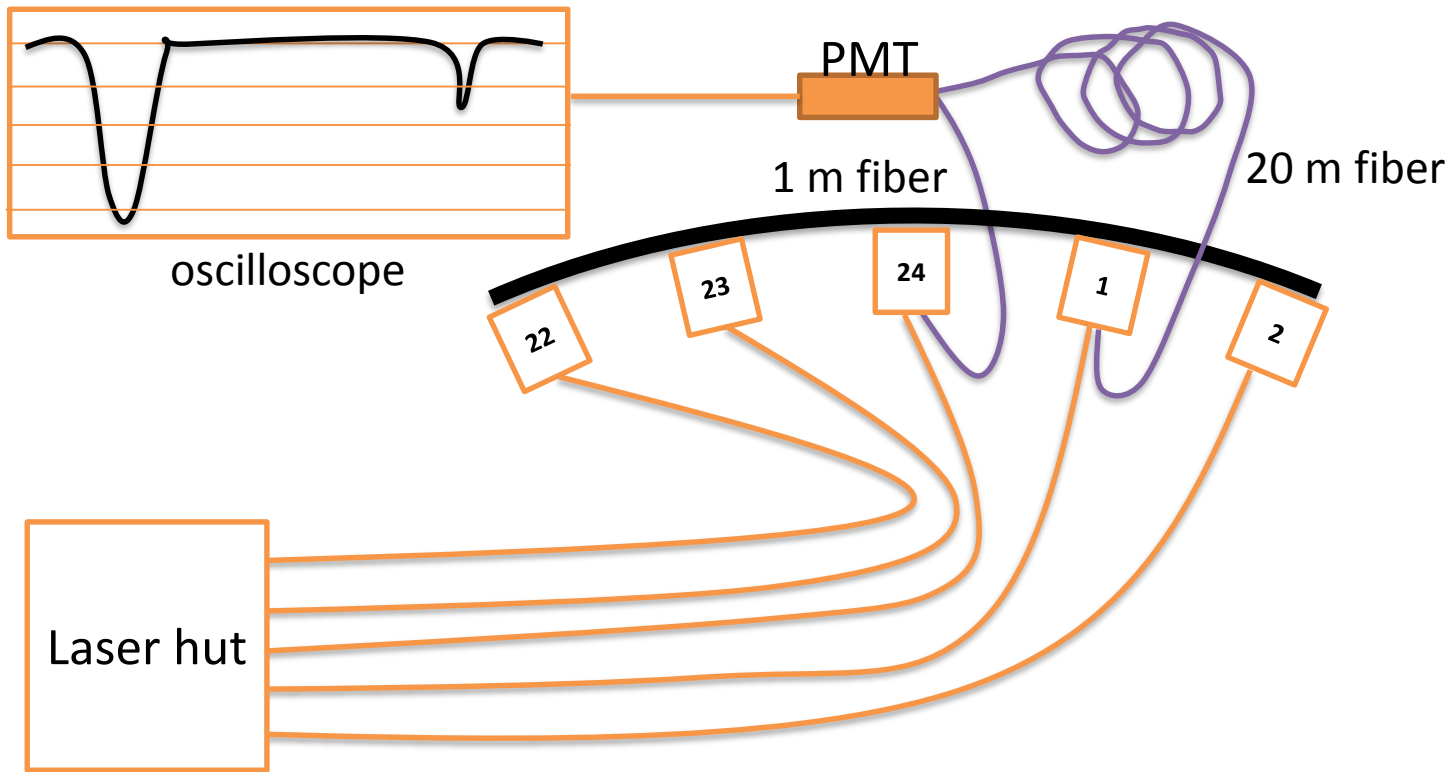
Hardware measurement of δ_F

- To get the hardware delay between calorimeters we send two pulses from two calorimeters through two fibers of different length.
